Tainter Gate Cleanout, Newburgh L&D

Louisville District, Ohio River

10 February 2015

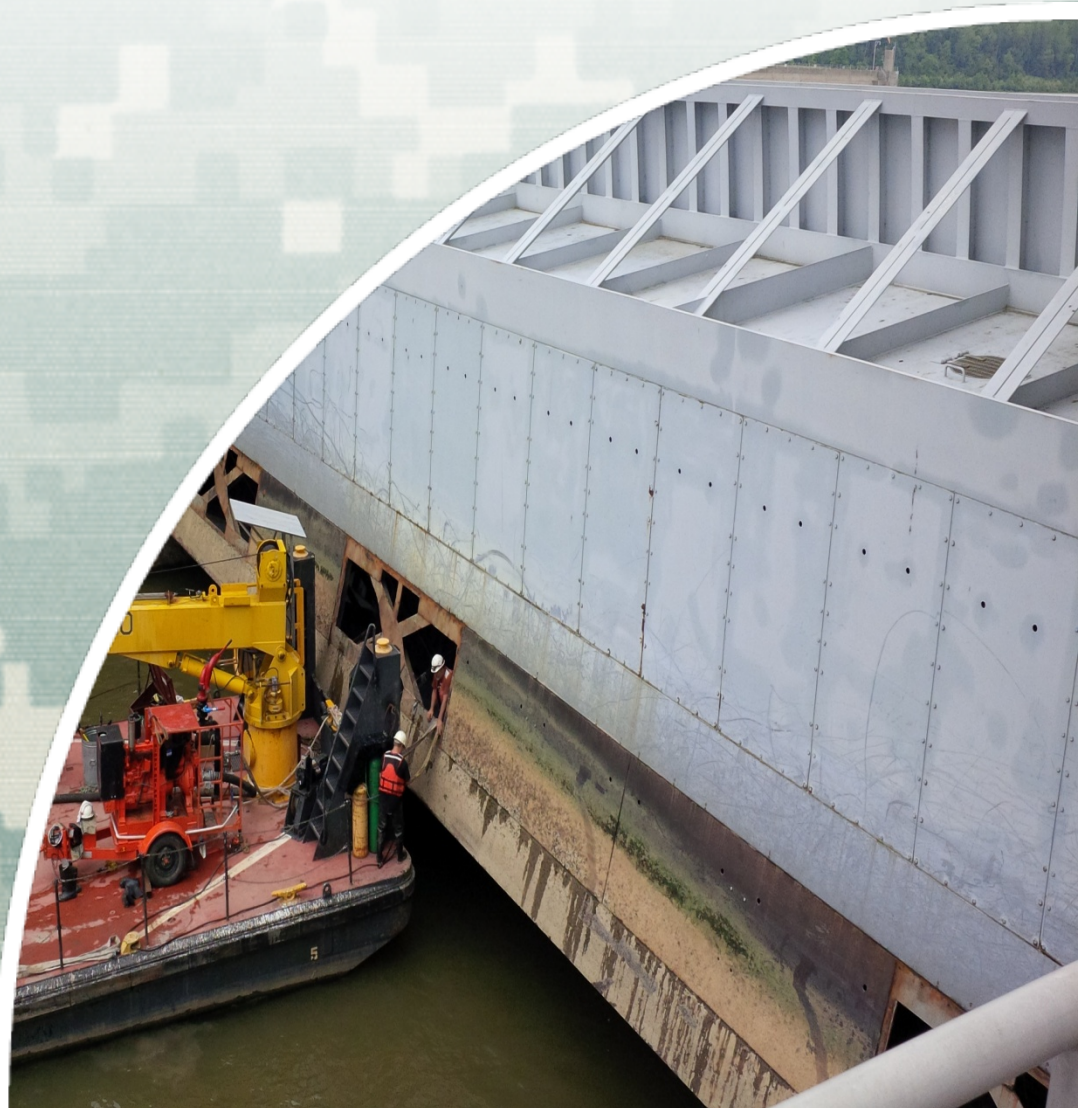
Newburgh Tainter Gate, 110' wide X 35' tall

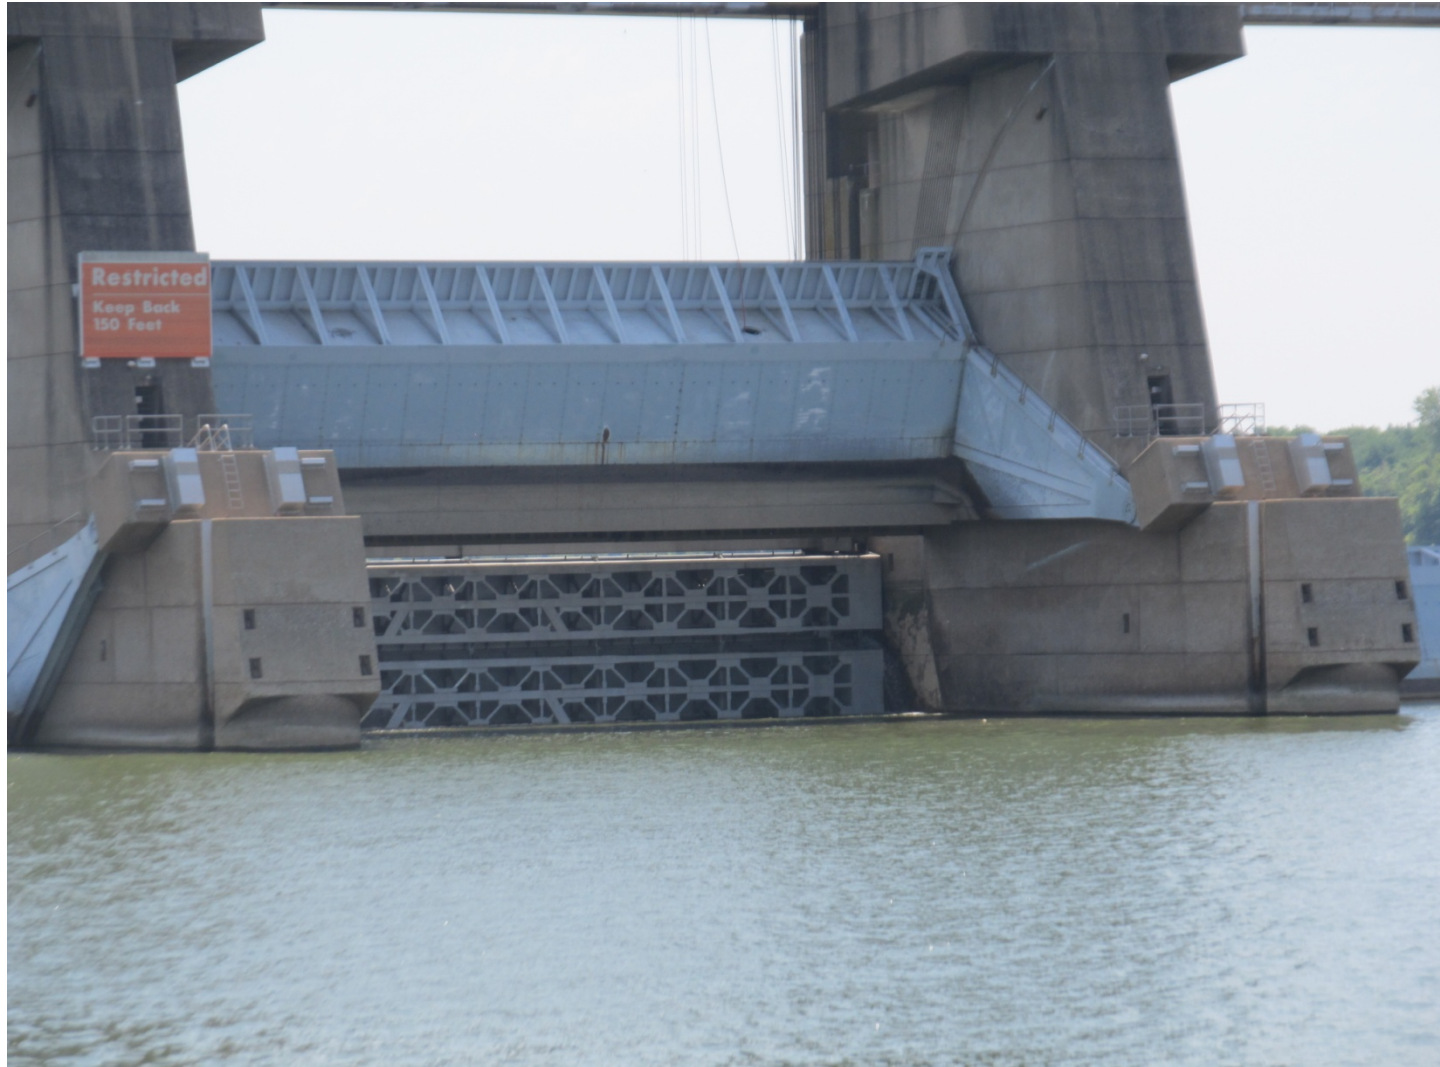
Mud and Debris in the Tainter Gate

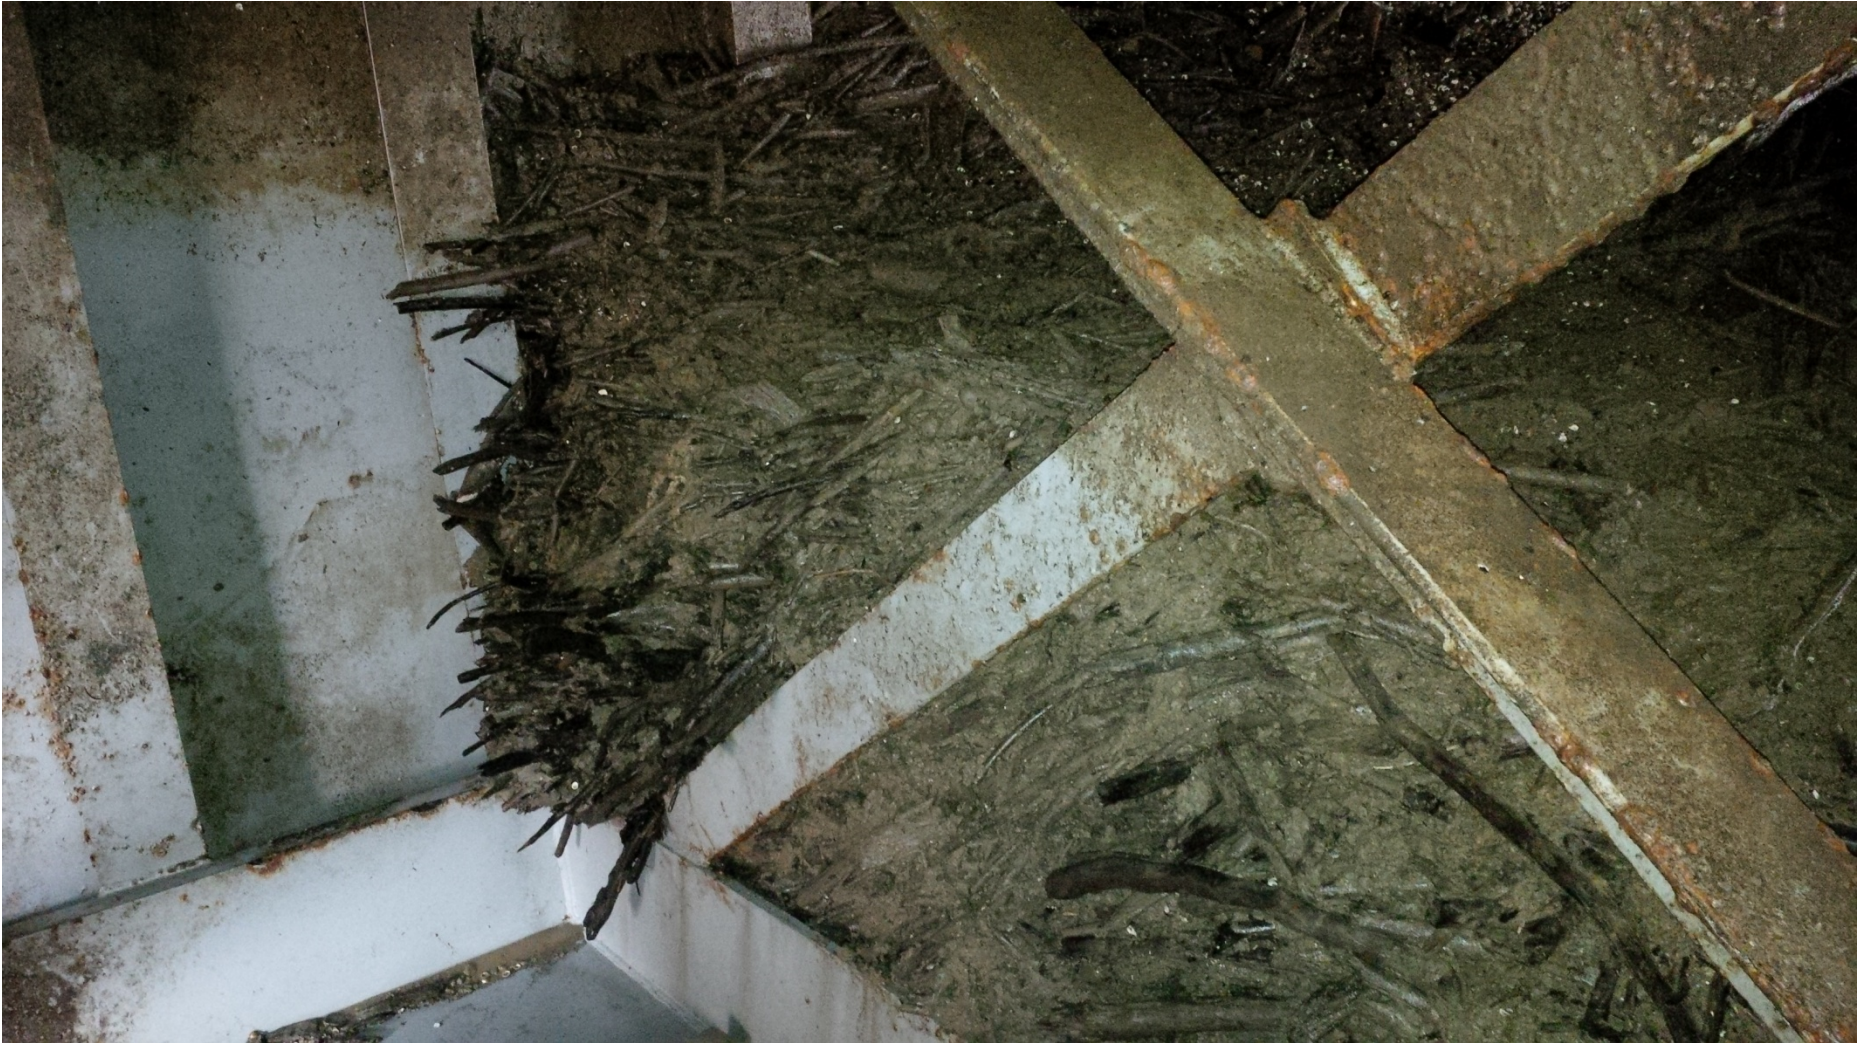
More mud and debris in a tainter gate

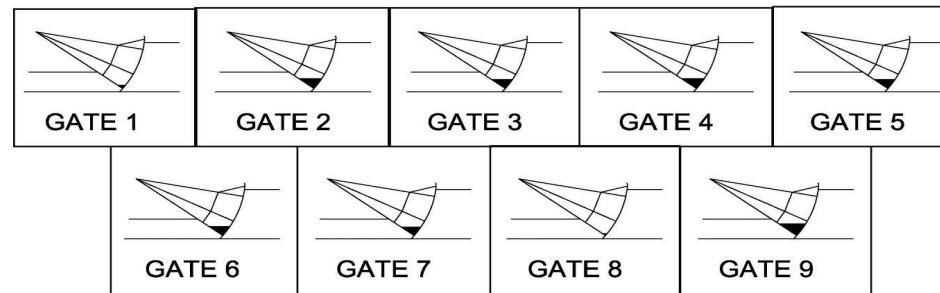
Figure 1. Graphical representation of level of mud in gates. Mud is dark shaded area in bottom of the gate body.

Gate	Mud Volume	Saturated Weight
	(ft ³)	(kip)
1	920	97
2	2889	303
3	2810	295
4	3672	386
5	3358	353
6	3672	386
7	2080	218
8	115	12
9	5397	567

567 kip of mud added to the 788 kip gate results in a total weight of approximately 1355 kip. The listed capacity of each hoist is 425 tons. The two hoists combine to provide a total listed capacity of 1700 kip per gate. The listed capacity of the hoist is not indicative of the capacity of every component of the mechanical system, and does not necessarily make allowance for the required factors of safety.

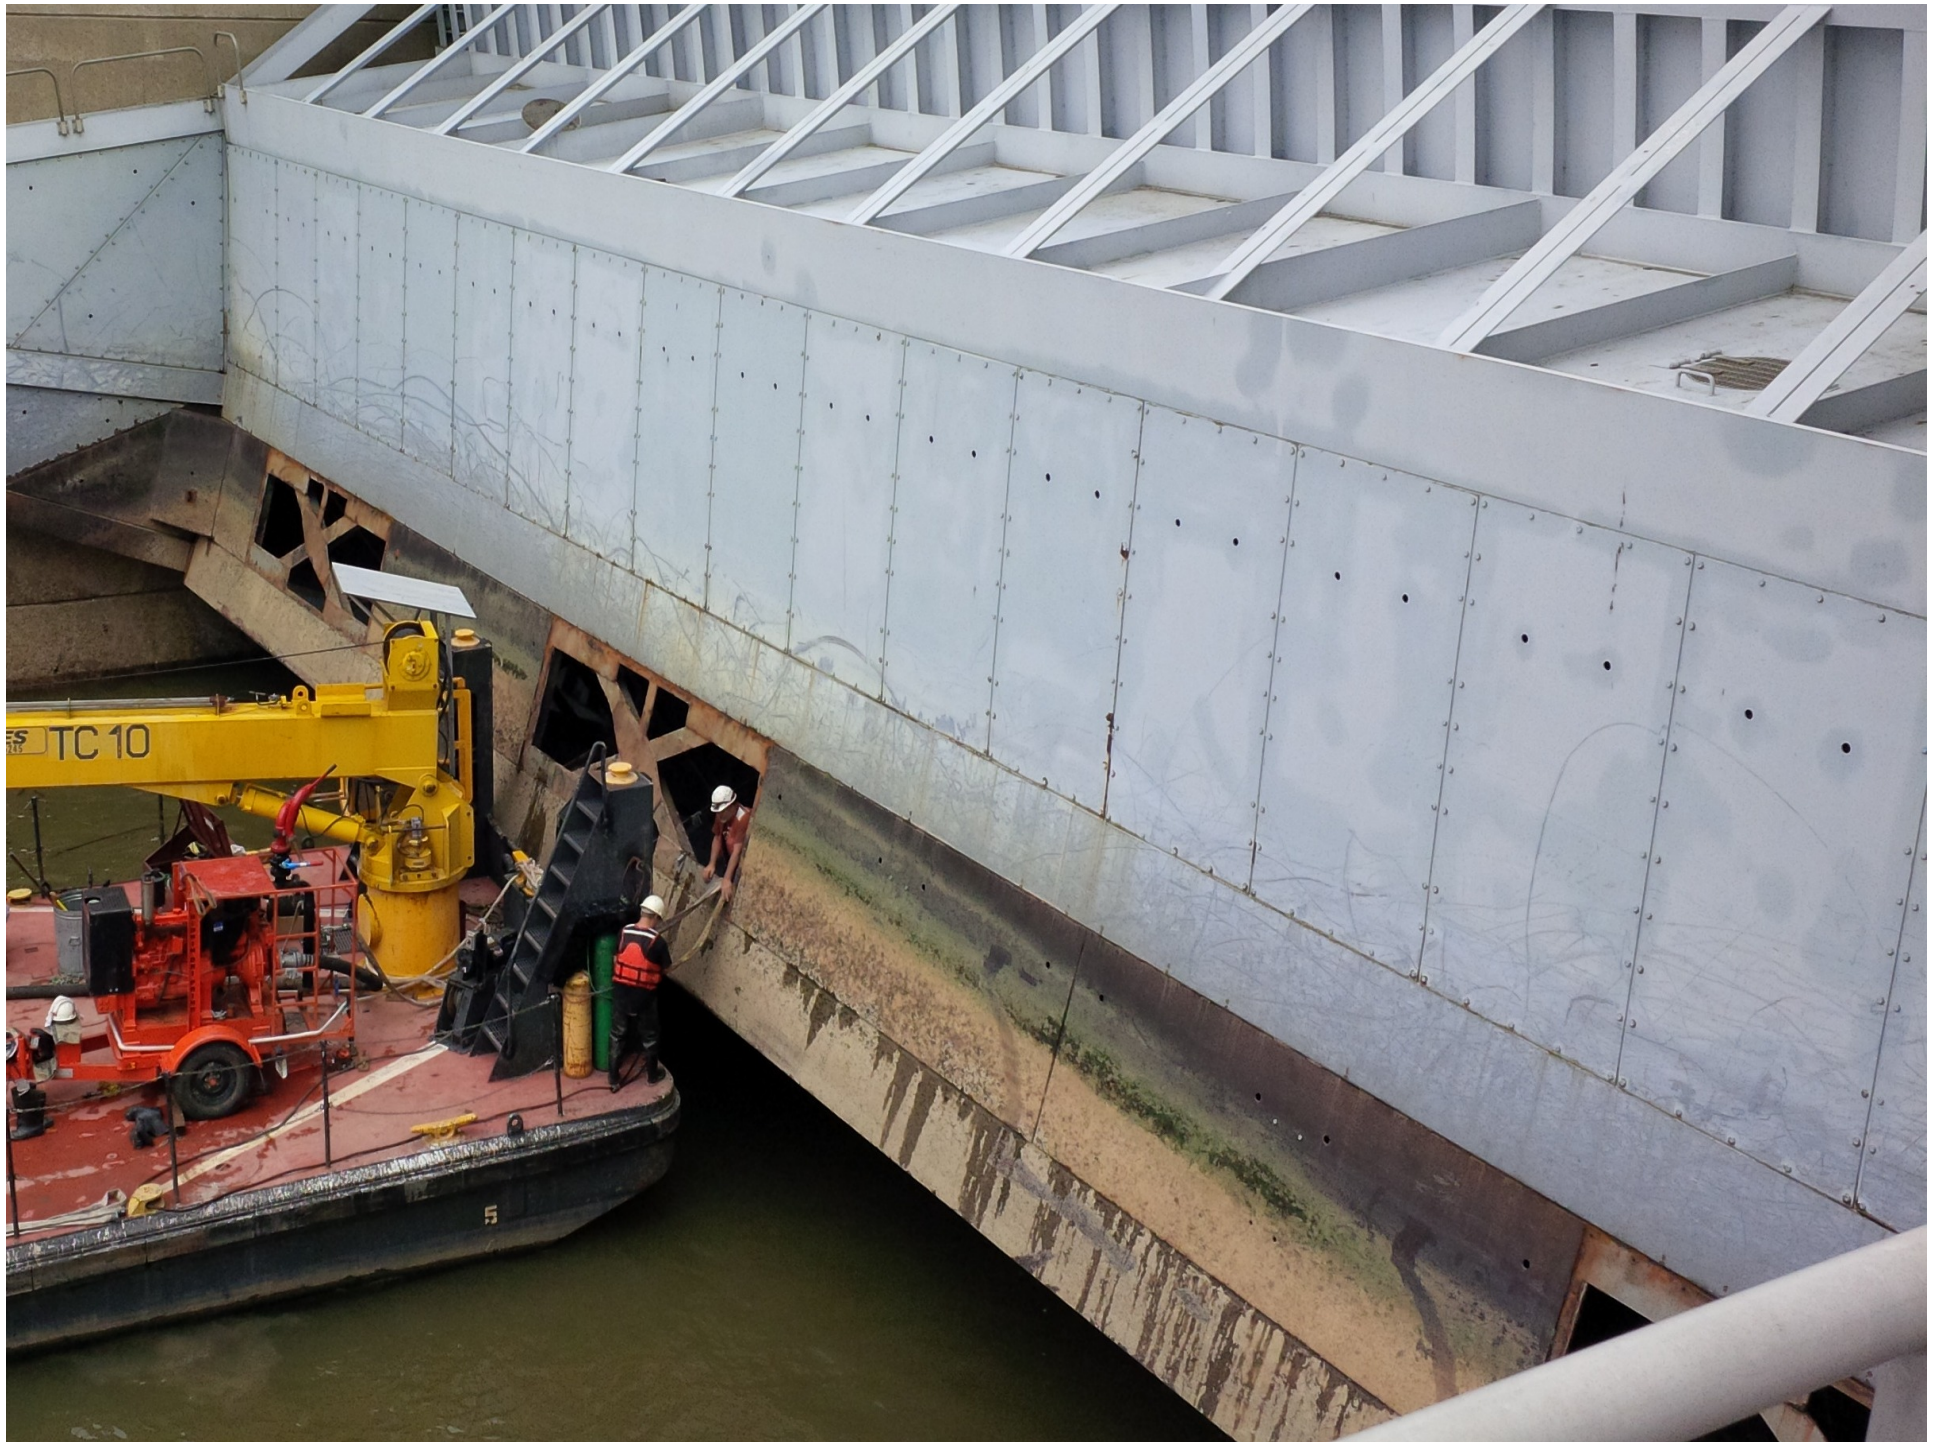
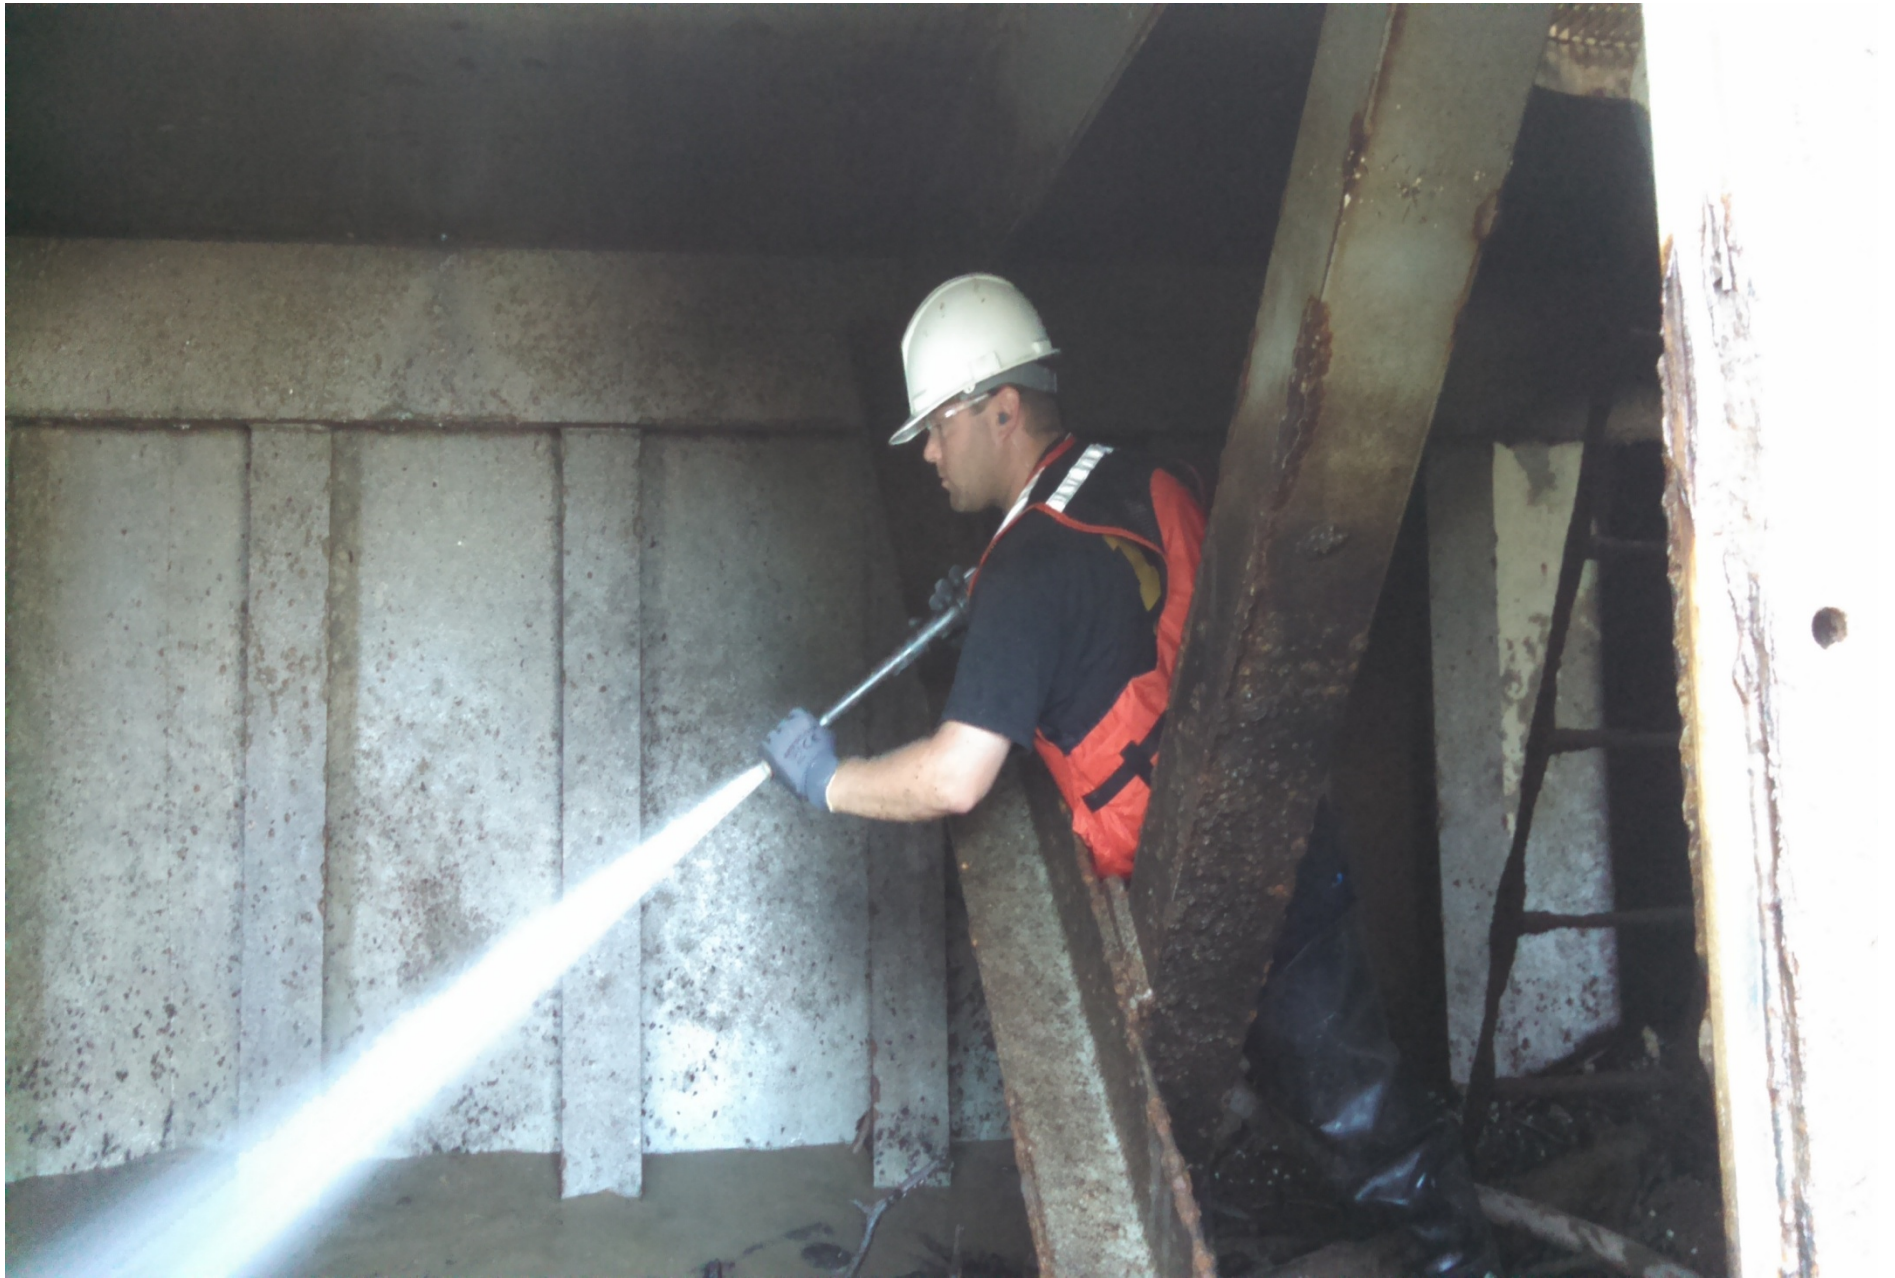
The lock crew started on gate nine. It had the most mud load and is the end gate on the KY side.

They removed 3 of the downstream skin sheets for access.

They remove by hand the large debris and washed clean one gate pan area, then they enlarged the 3" drain holes to about 10".

Next they removed large debris by hand and washed all the mud from the adjacent gate pan to the one they just cleaned with the enlarged 10" drain holes.

They then enlarged the 3" drain hole in the next gate pan and repeated the process.

Gate nine took 3 weeks to remove the mud and debris and re-install the three skin sheets.

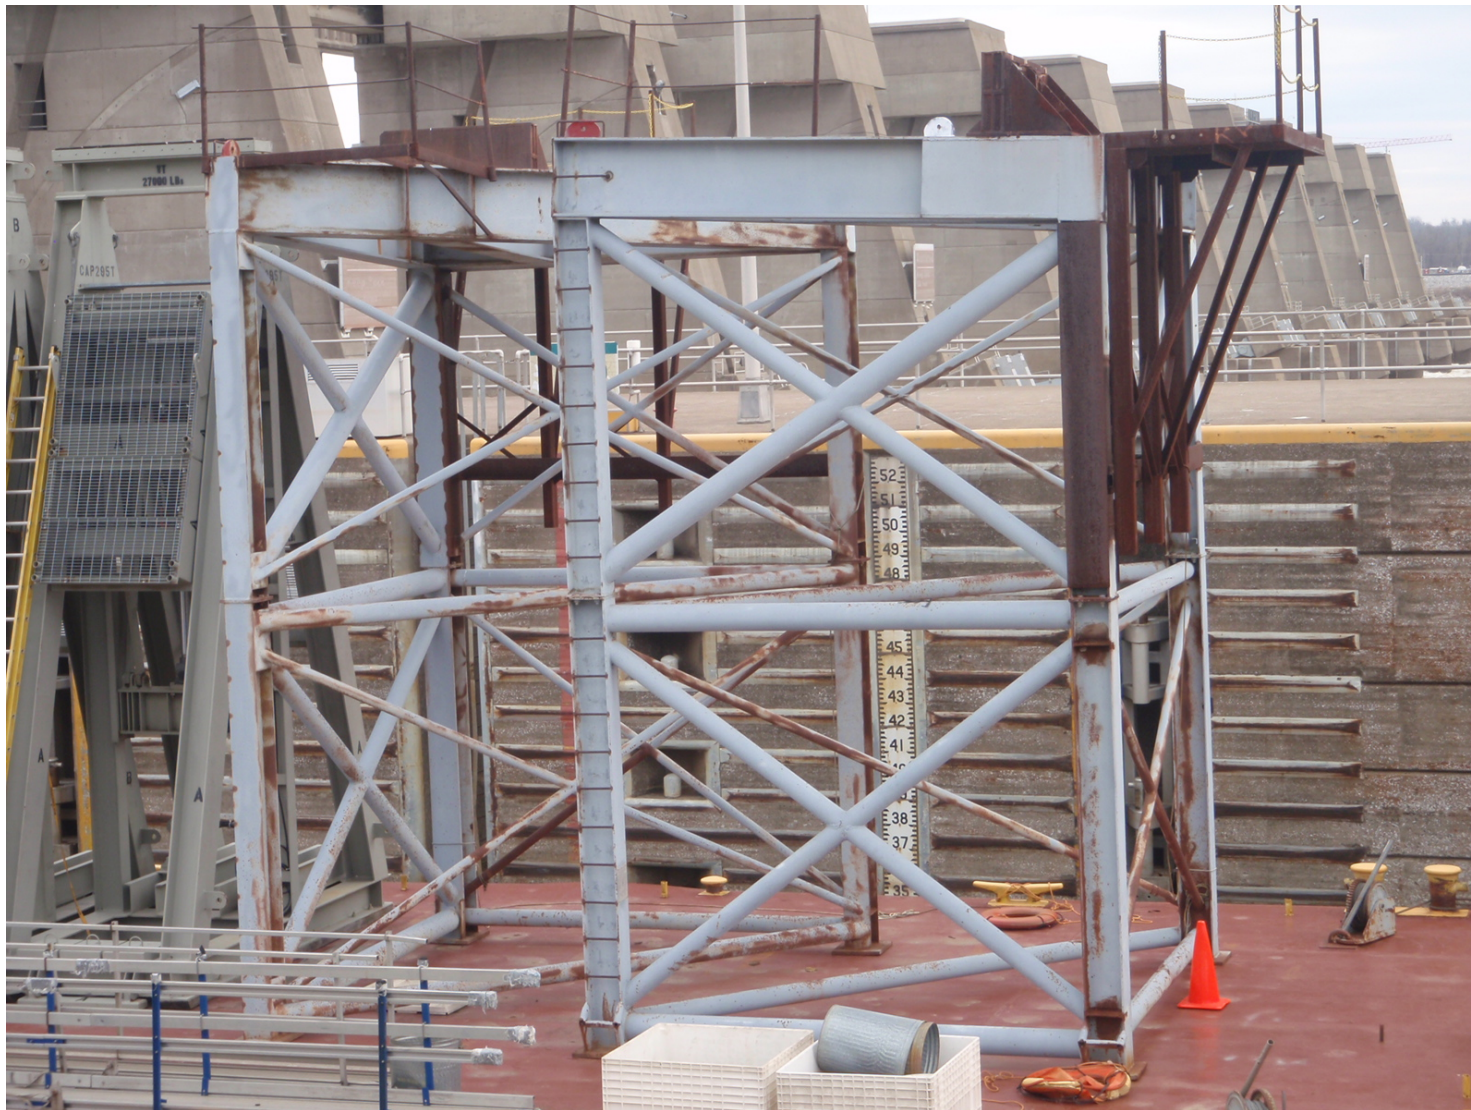
Tainter Gate Pedestals

Old style on the right have a 415 kip capacity each.

New Style on the left have a 590 kip capacity each.

If you remember from the previous slide, gate 9 weighed 677 kips each side.

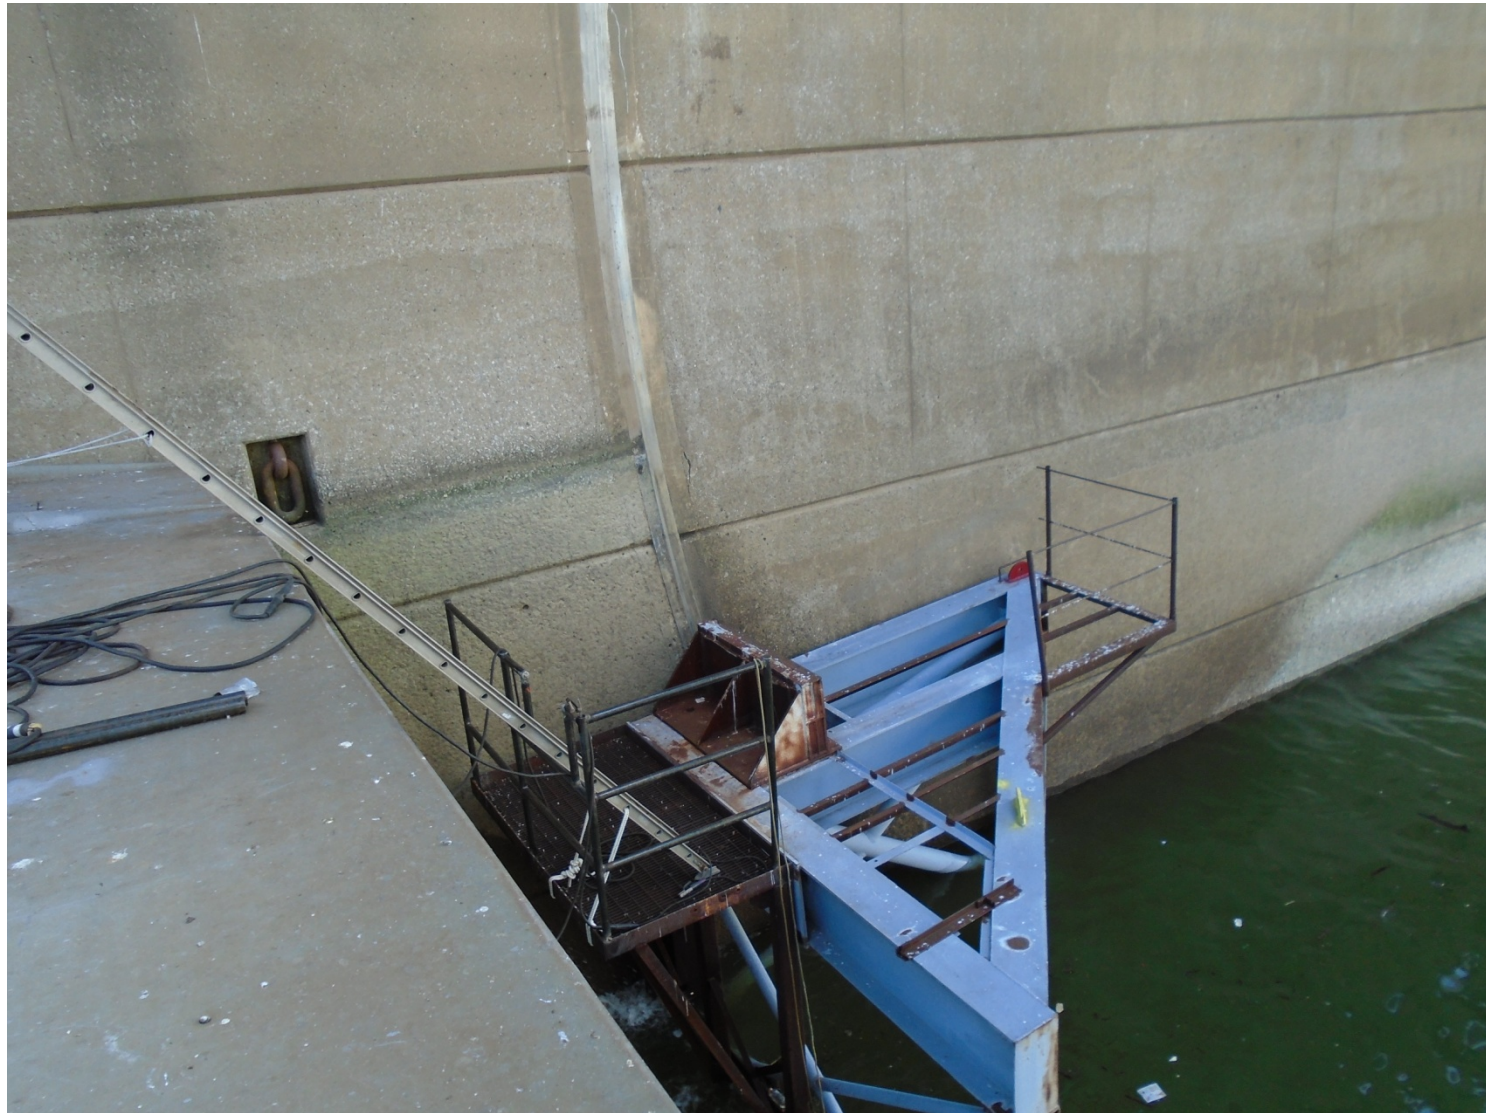
Old style tainter gate pedestals set and ready for use.

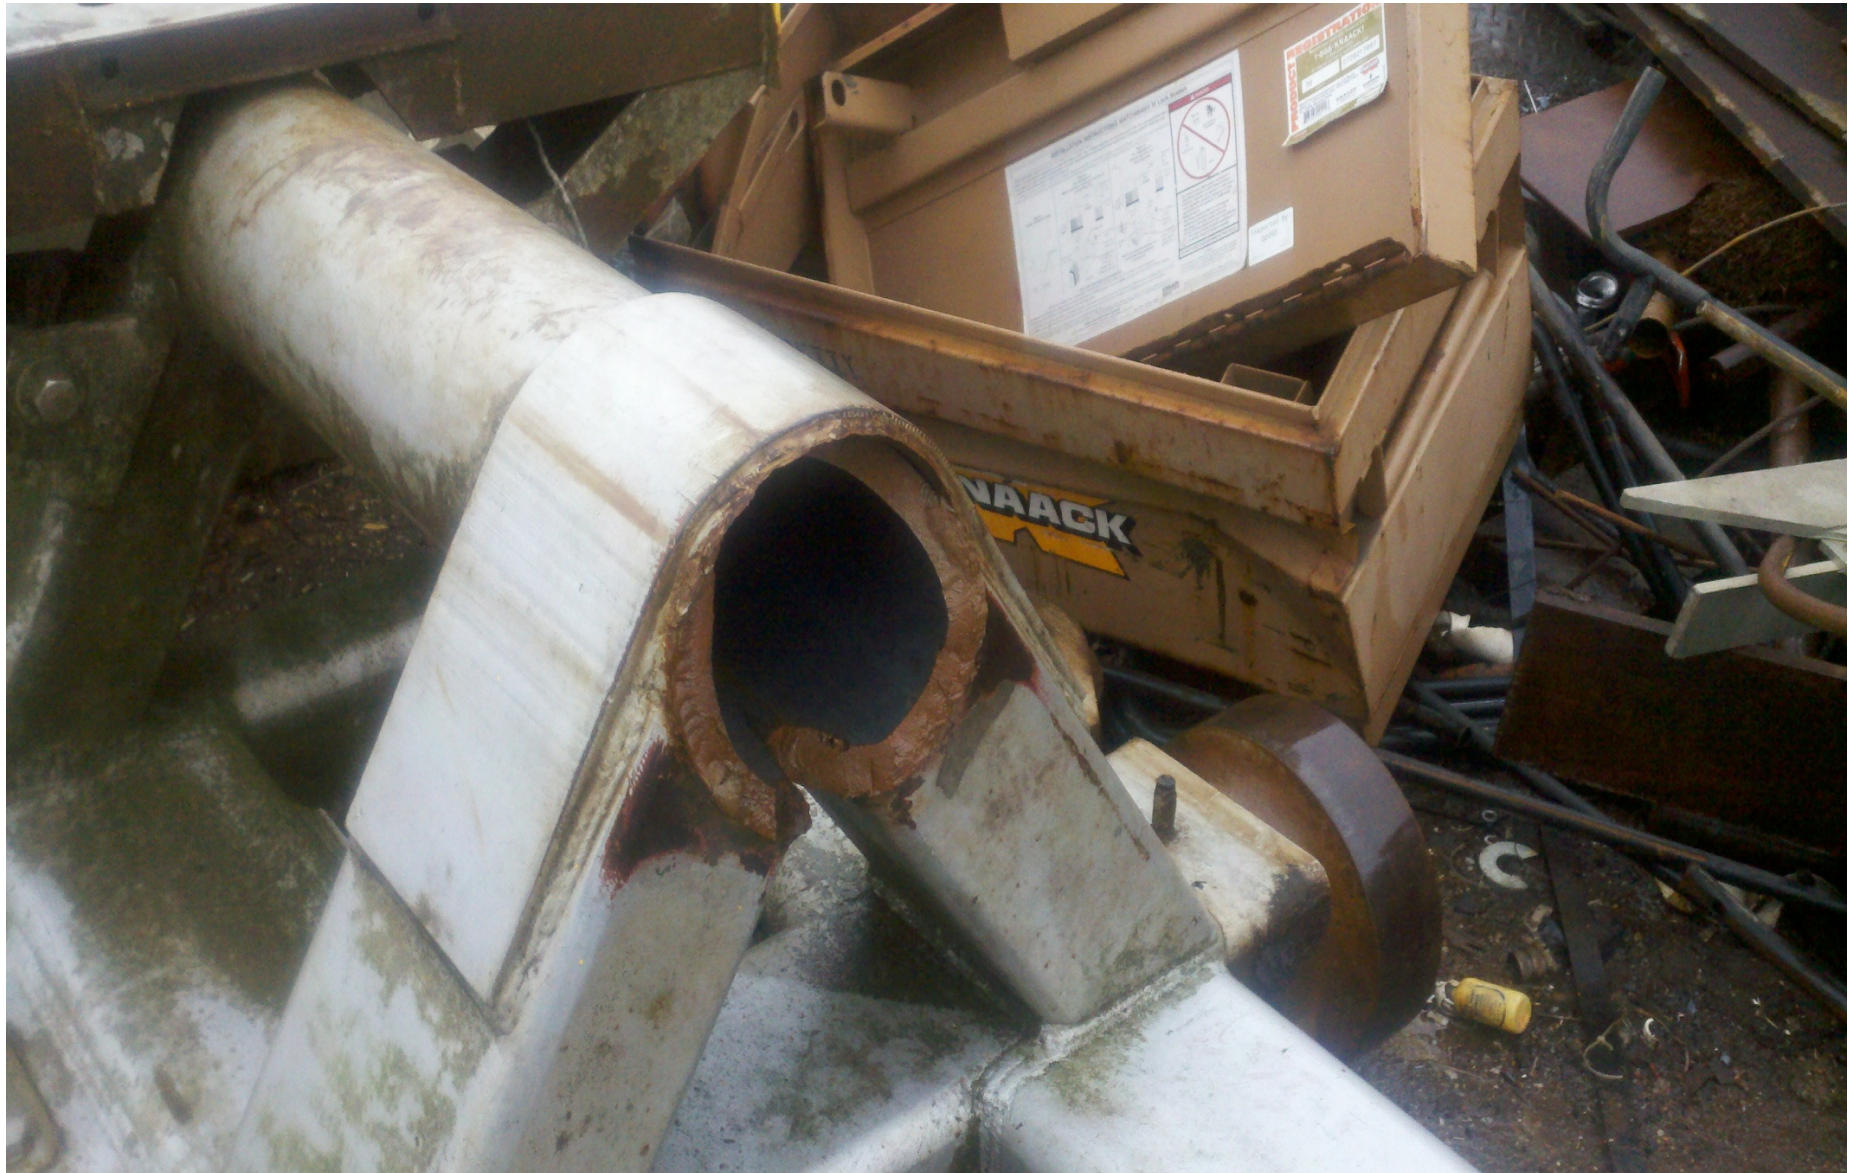
The top of this bit flew across the 110' chamber and landed on the 3rd barge over.

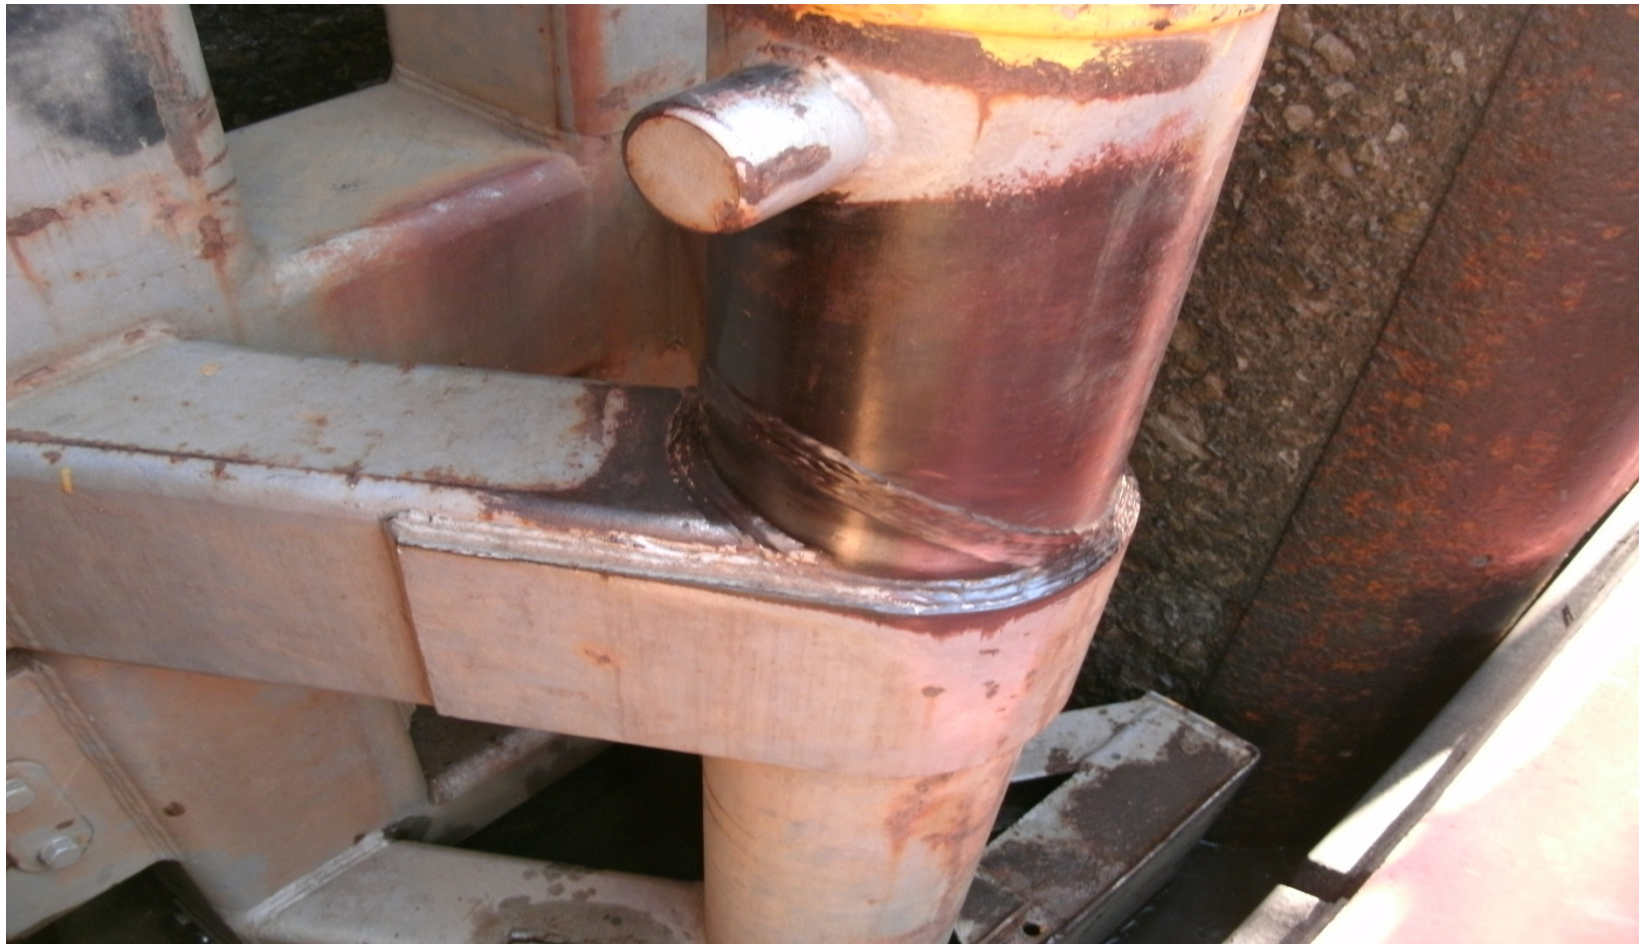
During inspection of the bitts I found a post that had tore off and been repaired sometime in the past.

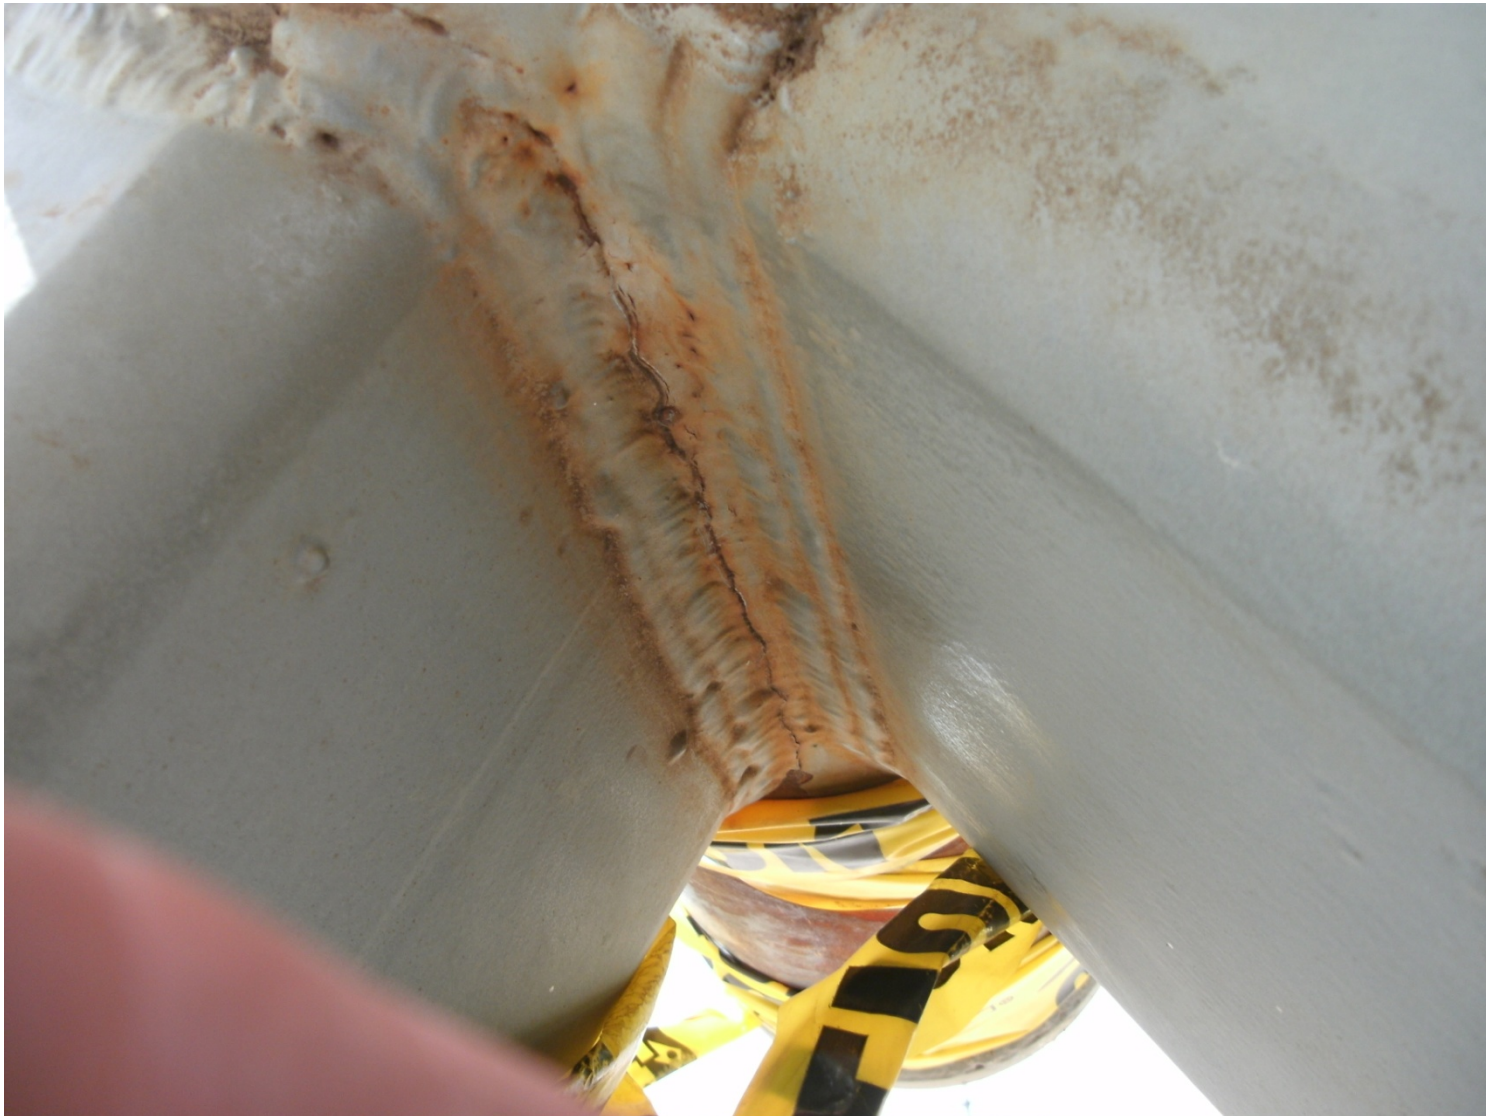
Cracked fillet weld, note both fillet weld edges touch each other.

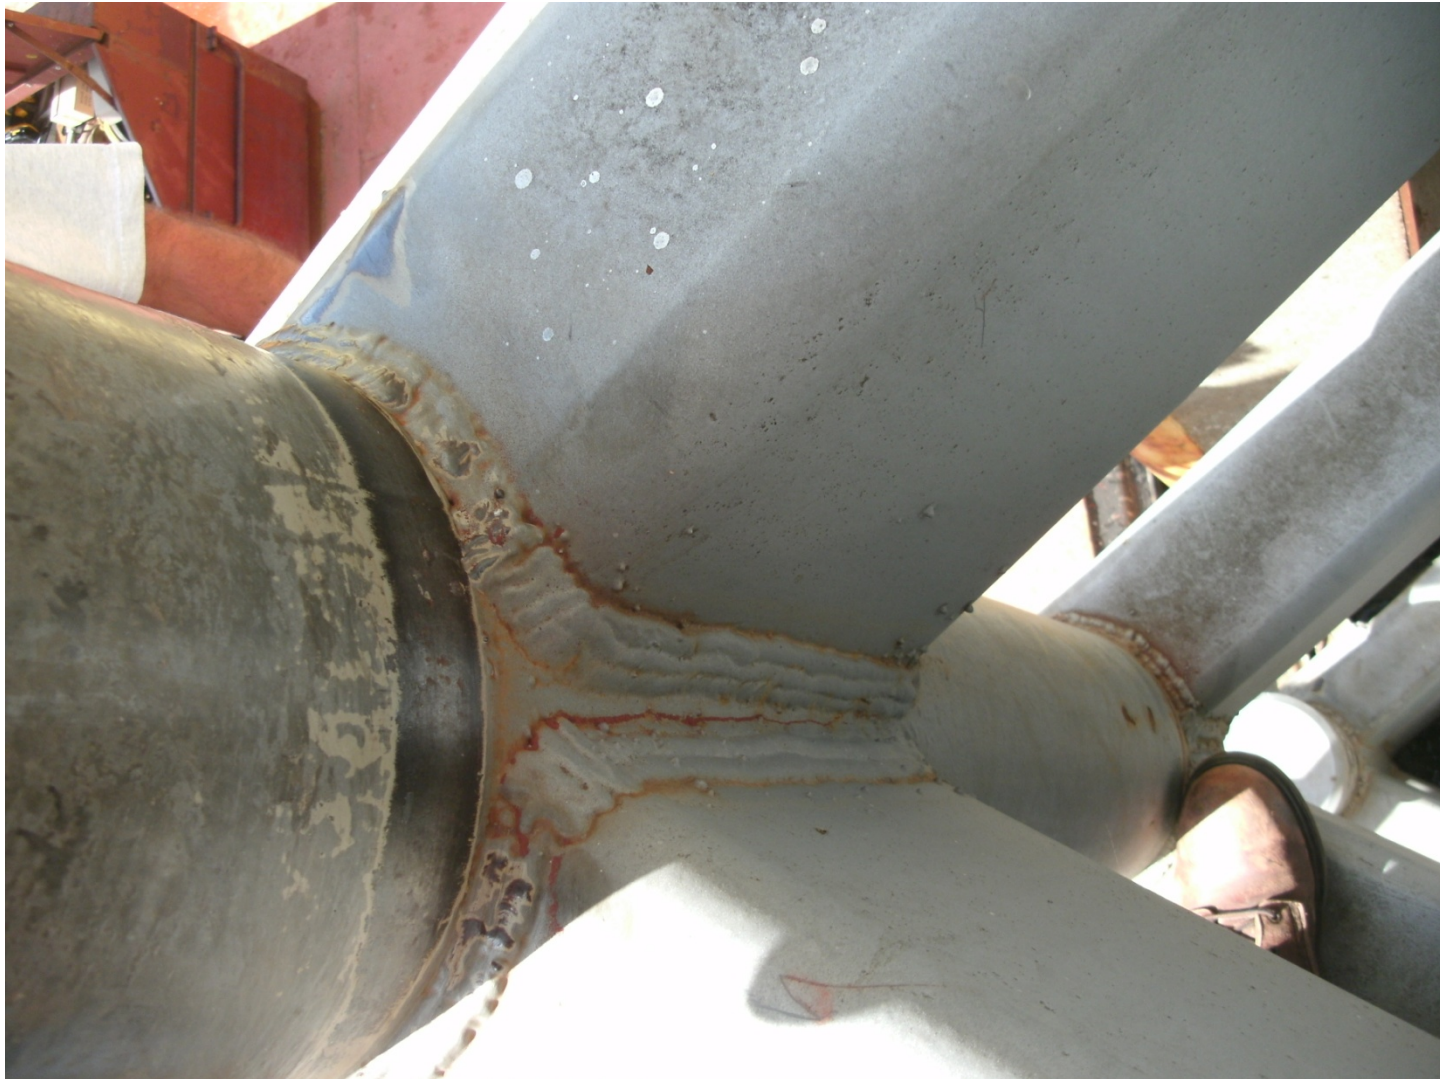
Crack leaving the edge of one fillet weld and propagating across towards the other

You might want to check your mooring bit posts.
